Manhole Inspection Summary

Manhole # S55A__004MH

Location Address: **3600 e fayette st**

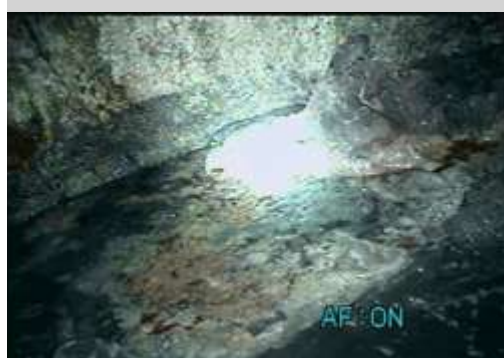
Defect 5

Condition: ☐ Sound ☐ Cracked ☐ Root Intrusion ☒ **Deteriorated** ☐ Leaks ☒ **Debris**

channel debris

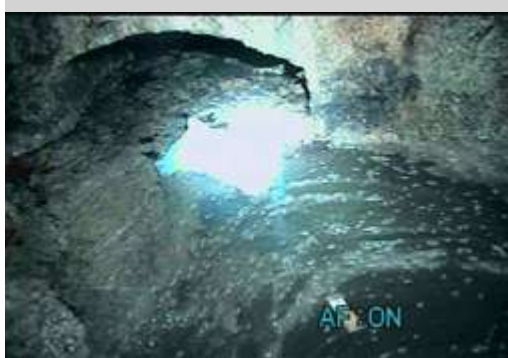
Defect 4

Condition: ☐ Sound ☐ Cracked ☐ Root Intrusion ☒ **Deteriorated** ☐ Leaks ☒ **Debris**

bench and channel deteriorated

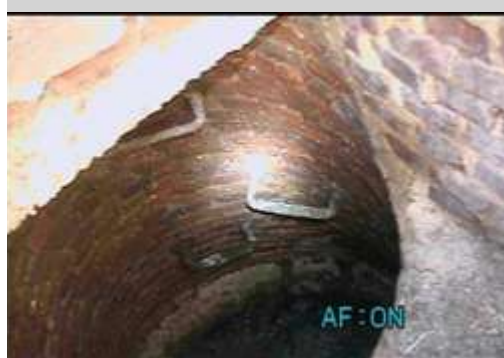
Defect 3

Steps Count: **4** Missing: **0** ☒ **Corroded**

steps on other side

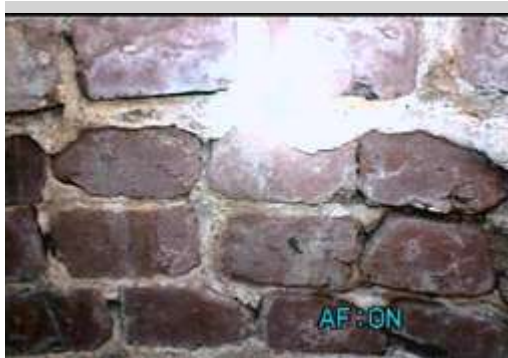
Defect 2

Condition: ☐ Sound ☒ **Cracked** ☐ Root Intrusion ☐ Loose Brick ☐ Deteriorated

Cracked Chimney

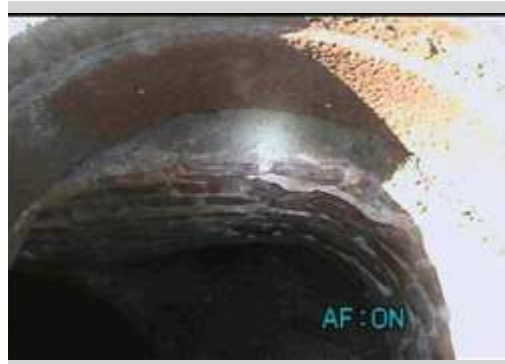
Defect 1

Frame Offset: **3** (in.) Condition: ☒ Sound ☐ Cracked ☐ Leaks

offset

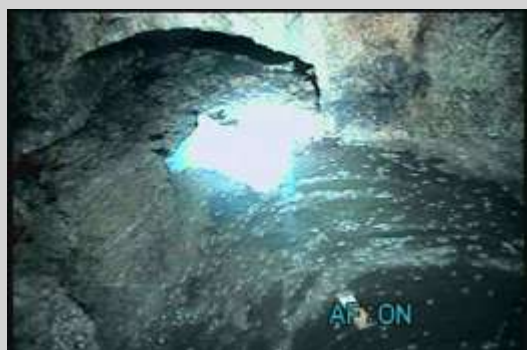
12 O'Clock Outflow

21 in. Circular Gravity Sewer
Pipe Out @ 12 O'Clock

Deposits: ☐ None ☐ Mud ☒ Sludge ☒ Debris ☐ Grease

Silt Depth: 6 (in.) Deposits Extent: Heavy

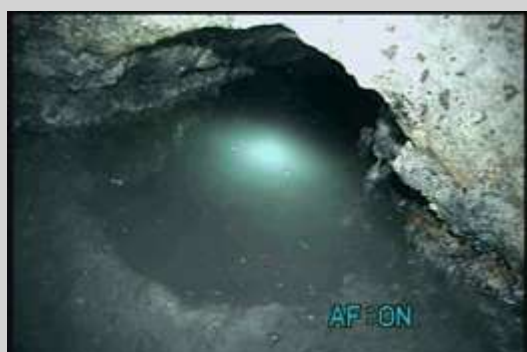
5 O'Clock Inflow

21 in. Circular Gravity Sewer
Pipe In @ 5 O'Clock

Deposits: ☒ None ☐ Mud ☐ Sludge ☐ Debris ☐ Grease
